## 6.3 ARCHITECTURAL COMPONENTS

### 6.3.1 EXTERIOR WALL COMPONENTS

#### 6.3.1.1 ADHERED VENEER

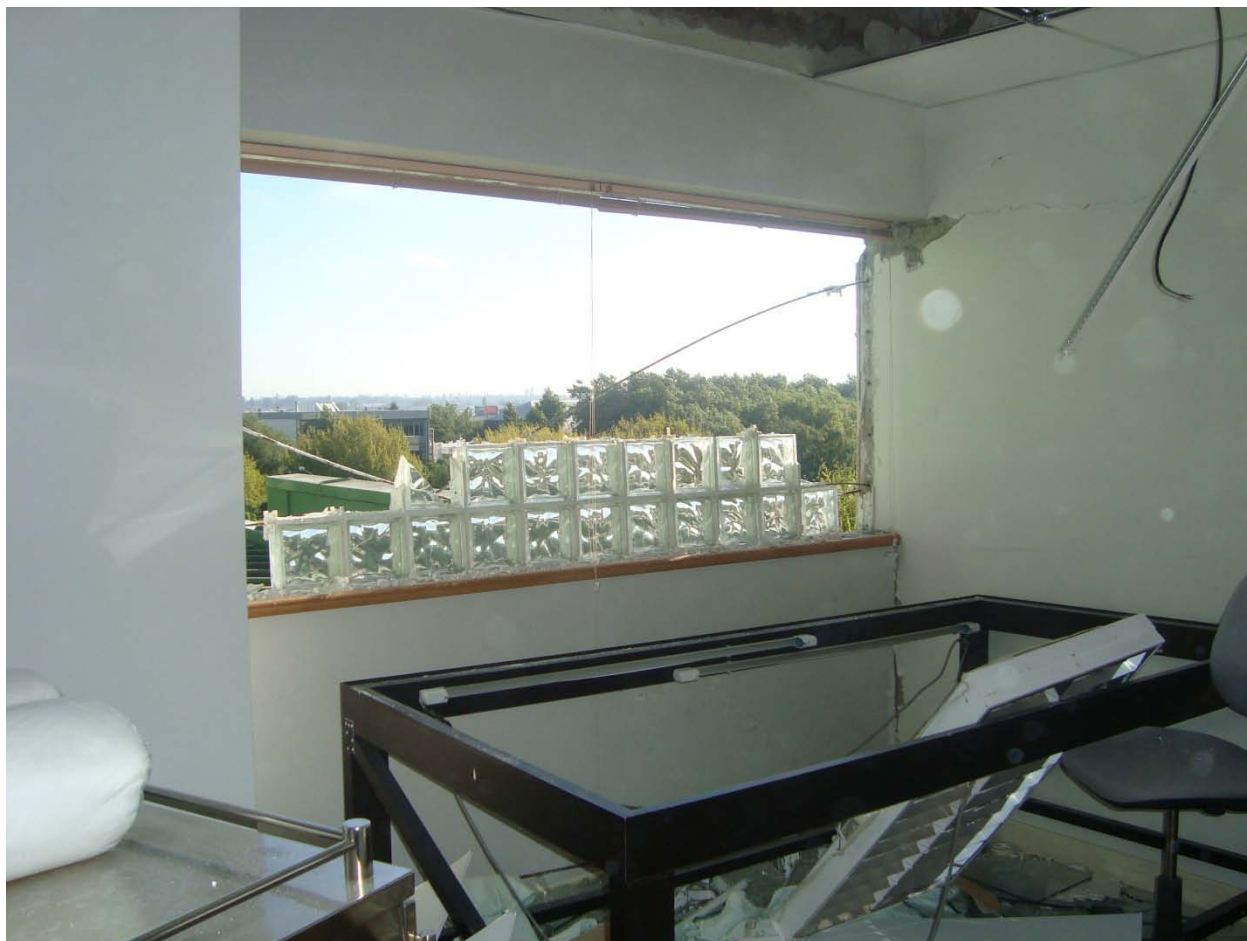
Figure 6.3.1.5-3 Damaged glass block panel from the Los Angeles Hospital in the 2010 Chile Earthquake; relatively new hospital building that had to be evacuated for repairs (Photo courtesy of Bill Holmes, Rutherford & Chekene). Blocks were installed with steel reinforcing bars in the top and bottom horizontal joints.

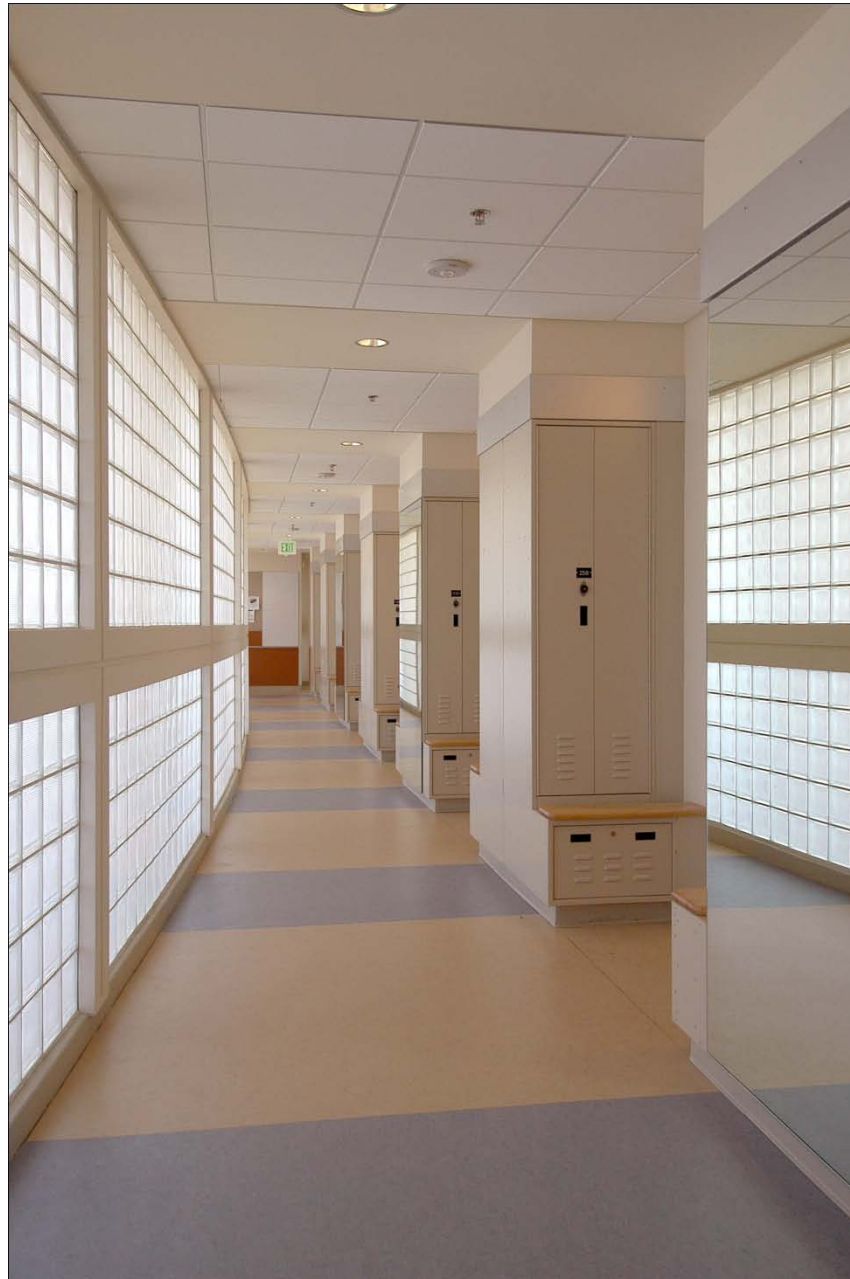
Figure 6.3.1.5-5 Glass block panels divided into numerous subpanels at the Chula Vista Police Headquarters, California (Photo courtesy of Pittsburgh Corning Corporation). In addition, the nonbearing glass block panel partition wall is isolated from seismic movement of the building structure.
